Manhole Inspection Summary

Manhole # S45II_009MH

Inspection ☐ Is Incomplete Rating: **3) Fair**

Location Address: **Oliver St**

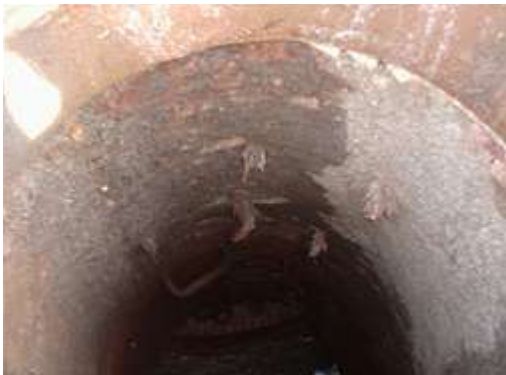
Defect 1

Infiltration: ☐ None ☐ Joint ☐ Cracks ☐ Mortar ☐ Roots ☒ **Wall**

Infiltration

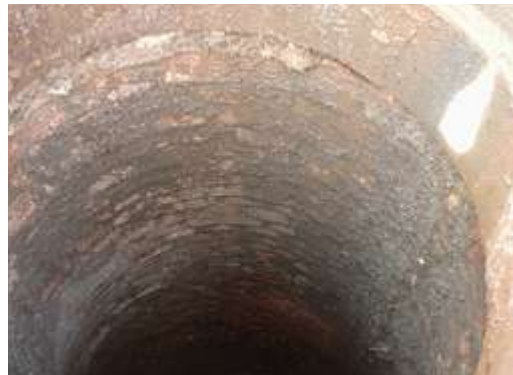
Defect 2

Frame Leaks

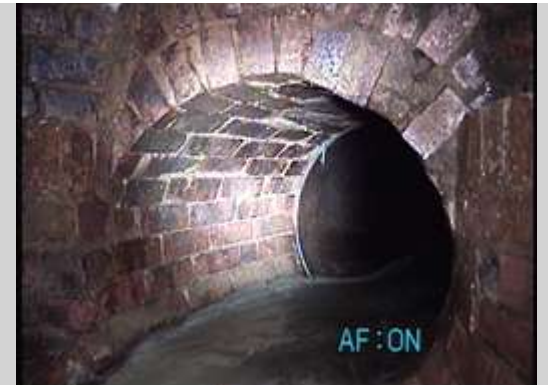
12 O'Clock Outflow

22 in. Circular Gravity Sewer
Pipe Out @ 12 O'Clock

Pipe Height: **21.6** (in.) Rod and Bar (Angled)
Pipe Material: **Clay** ☐ Pipe Lined
Invert Depth: **14.90** (ft.) Flow Characteristics: **Fast**
Deposits: ☒ None ☐ Mud ☐ Sludge ☐ **Debris** ☐ Grease
Silt Depth: (in.) Deposits Extent:
Infiltration: **None** Pipe Seal Cond: **Sound**

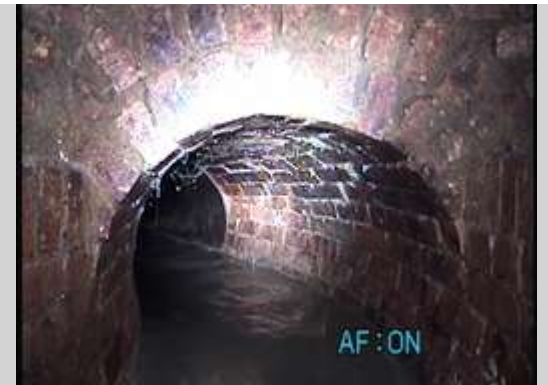
4 O'Clock Inflow

22 in. Circular Gravity Sewer
Pipe In @ 4 O'Clock

Pipe Height: **21.6** (in.) Rod and Bar (Angled)
Pipe Material: **Clay** ☐ Pipe Lined
Invert Depth: **14.80** (ft.) Flow Characteristics: **Fast**
Deposits: ☒ None ☐ Mud ☐ Sludge ☐ **Debris** ☐ Grease
Silt Depth: (in.) Deposits Extent:
Infiltration: **None** Pipe Seal Cond: **Sound**

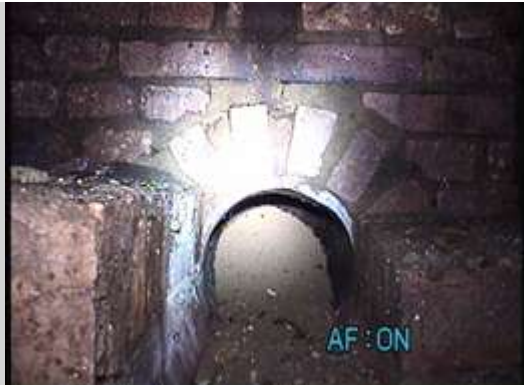
6 O'Clock Inflow

Deposits: ☐ None ☐ Mud ☐ Sludge ☒ **Debris** ☐ Grease

Silt Depth: **2** (in.) Deposits Extent: **Light**

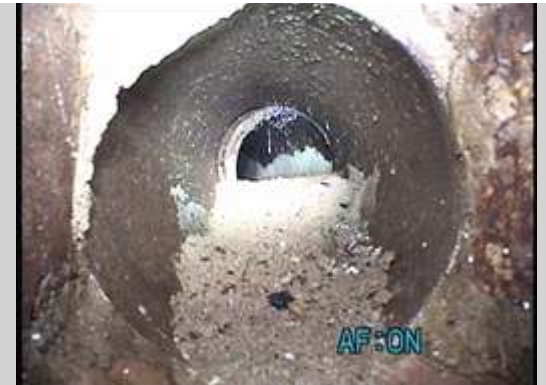
9 O'Clock Inflow

Deposits: ☐ None ☐ Mud ☐ Sludge ☒ **Debris** ☐ Grease

Silt Depth: **4** (in.) Deposits Extent: **Medium**
